DEER LAKE DAM
FAYETTE COUNTY, COMMONWEALTH OF PENNSYLVANIA
NDI No. PA 01139
PennDER No. 26-53

(6) PHASE I INSPECTION REPORT,
NATIONAL DAM SAFETY PROGRAM.

Deer Lake Dam, Fayette County, Pennsylvania
NDI No. PA 01139, PennDER No. 26-53
Meadow Run
Inspected 22 July 1980

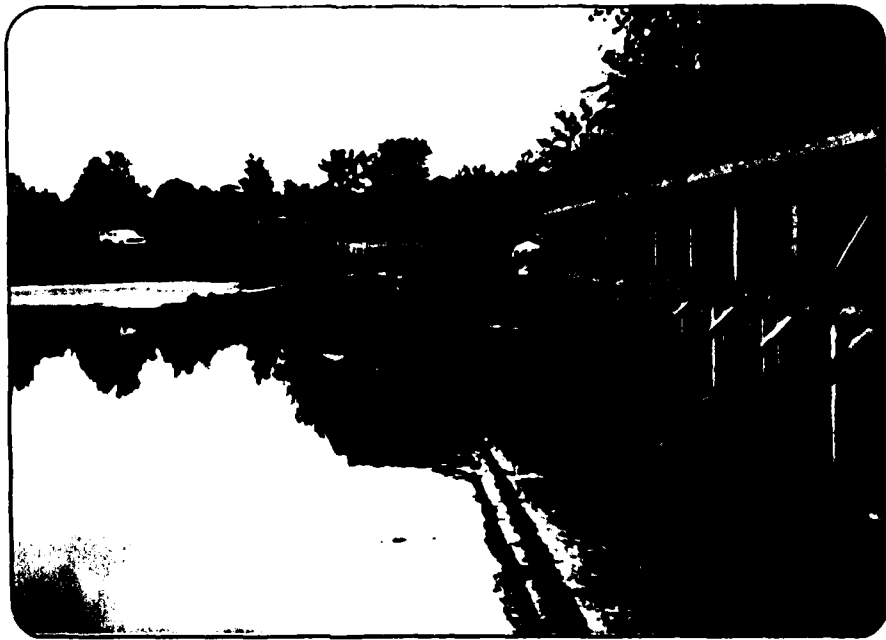
**Overall View from Right Training Wall of Central Spillway
Looking at Left Embankment**

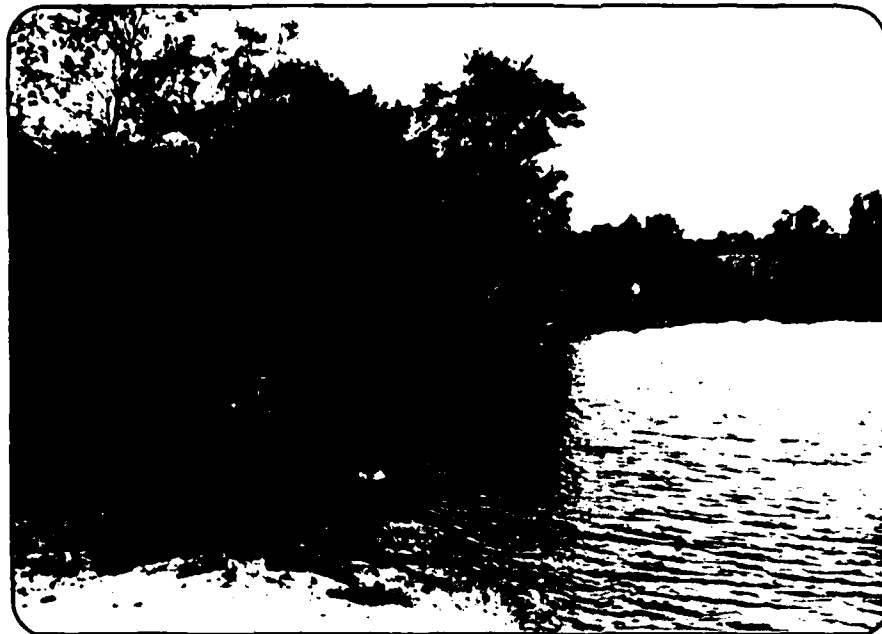
PHOTO 1. View of Upstream Side of Central Spillway

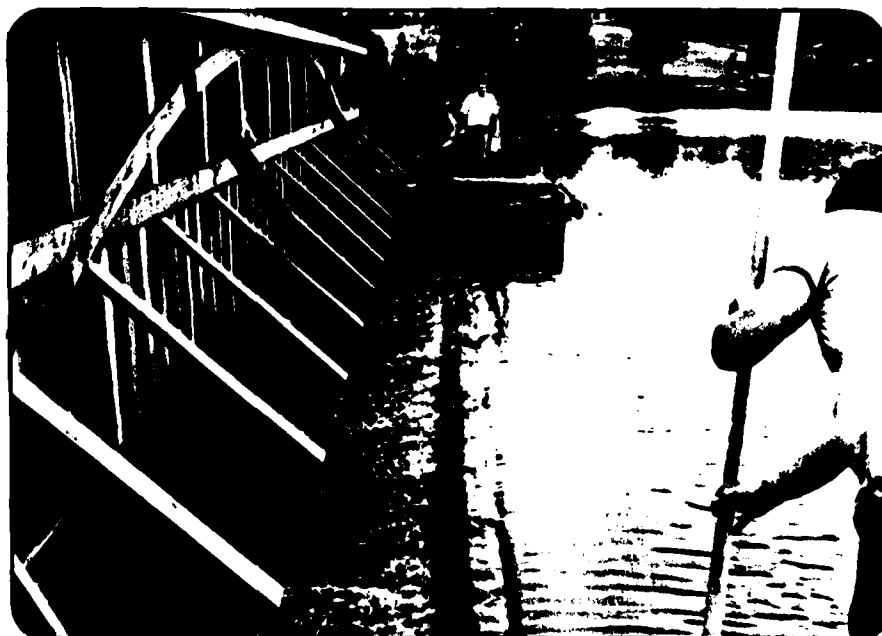
- a) The concrete weir is cracked and leaking and should be repaired.
- b) Some erosion has occurred in the discharge channel to the right of the right training wall. This erosion should be repaired.

**PHOTO 2. View from Left Training Wall of Central Spillway
Looking across Weir**

- 10) Repoint the stone training walls of the left spillway.
- 11) Repair the concrete weir of the central spillway.
- 12) Repoint the stone training walls of the right spillway.

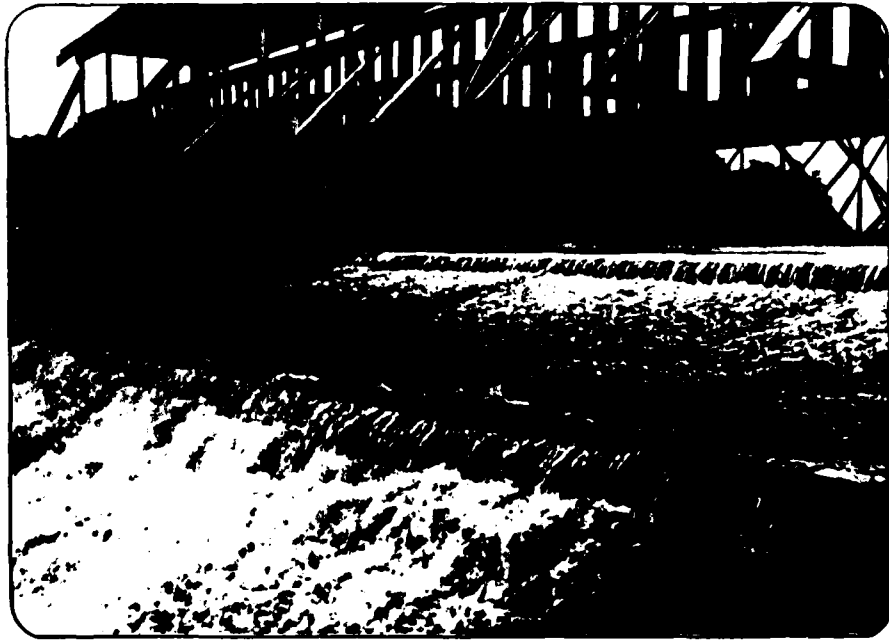
VISUAL EXAMINATION OF		OBSERVATIONS	REMARKS OR RECOMMENDATIONS
CONCRETE WEIR		The spillway consists of a concrete bottom with sides of rough stone mortared together.	The concrete weir shows signs of crumbling and should be repaired.
APPROACH CHANNEL		The reservoir serves as the approach channel.	
DISCHARGE CHANNEL		The discharge channel consists of stone steps mortared together. Some erosion has occurred on the right side of the spillway.	The area of erosion should be repaired.
BRIDGE AND PIERS		A wooden footbridge spans the discharge channel. The bridge appears to be in good condition.

PHOTO 3. View of Central Spillway Weir Looking Upstream from
Left Training Wall

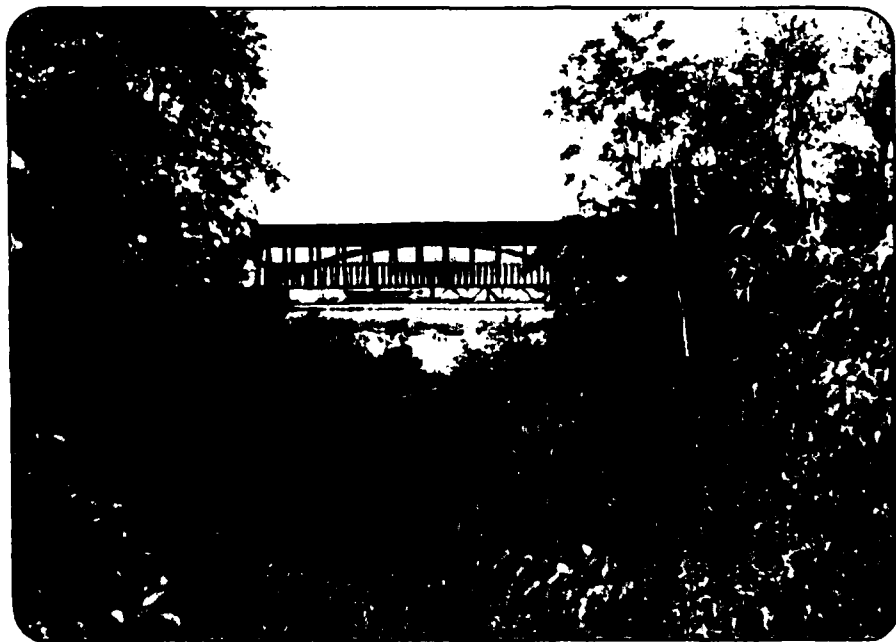
PHOTO 4. View Looking Upstream at Central Spillway

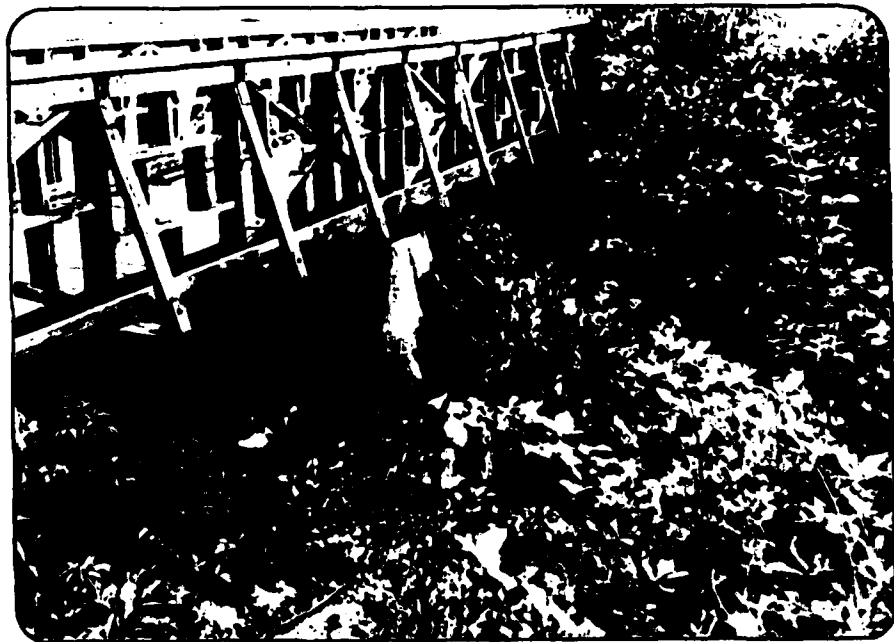
- d) The discharge channel curves back toward the dam and is undermining the embankment toe. The channel should be relocated away from the toe and the eroded area repaired.

The discharge channel consists of a stone bottom with sides of rough stone mortared together. There was some debris in the channel. Some of the stones in the sides had cracks in the mortar and were loose. The channel alignment curves back toward the dam and has seriously undercut the toe of the embankment.

**PHOTO 8. View of Downstream Side of Right Spillway from
Right Training Wall**

Debris should be removed from the channel. Any loose stones or stones with cracks in the mortar should be repointed. The discharge channel should be realigned away from the toe and the toe erosion repaired.
